# Monitoring Bluff Erosion Along Pennsylvania's Portion of the Lake Erie Shoreline

Prepared by  
Paul D. Knuth  
Richard Lindenberg, Ph.D.  
Edinboro University of Pennsylvania  
Institute for Research and Community Service

October 30, 1995

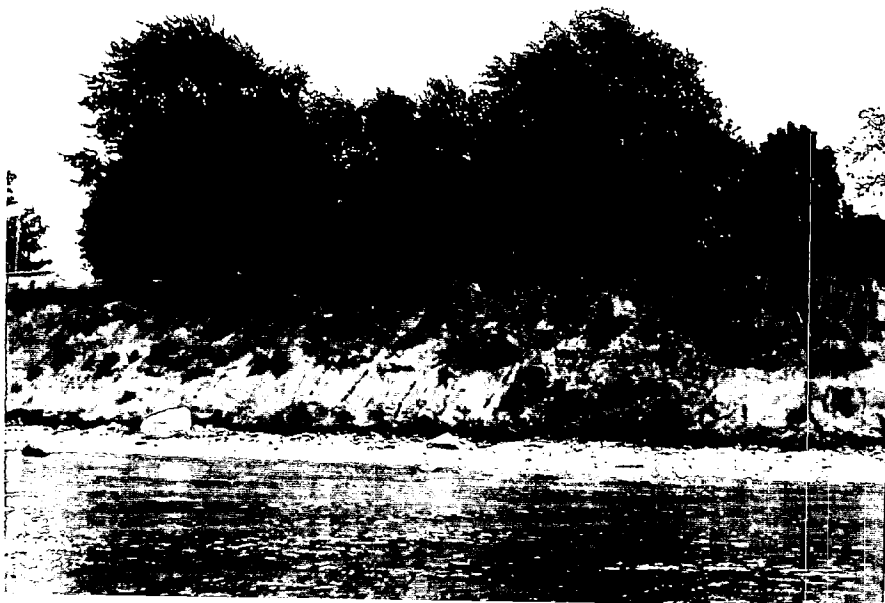
### Photo # 3

This is a steeply sloping bluff viewed from just offshore of control point number 7.0. The bluff face is linear because the till layers are retreating along a parallel plane. If the lower layer were less resistant to erosion the bluff would be far steeper. If the upper layer were more erodible, the slope angle would be steeper in the upper slope, less steep in the lower slope producing a compound slope angle. The large rocks are eroding out of the lower till layers.
